Figure 2-2
Cumulative Recovery Of PSH and Groundwater by the RCS
Motiva Enterprises Fairfax Terminal

Figure 2-5 **Benzene Concentrations** March 2016

> **MOTIVA Enterprises Fairfax Terminal**

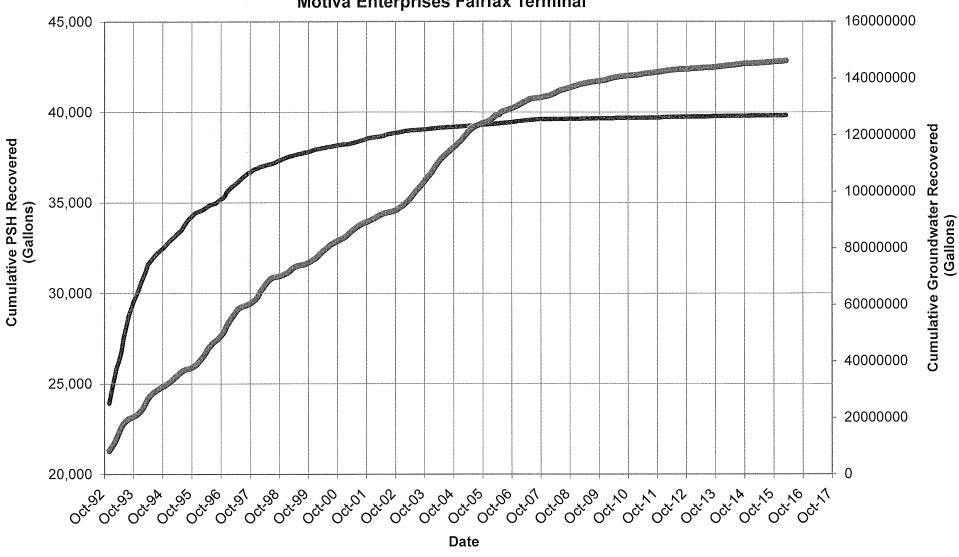
PSH Recovery per month Groundwater Recovery per Month
